Our Ocean Backyard — *Santa Cruz Sentinel* columns by Gary Griggs, Director, Institute of Marine Sciences, UC Santa Cruz.

**#103 April 7, 2012
Moving Sand Around**

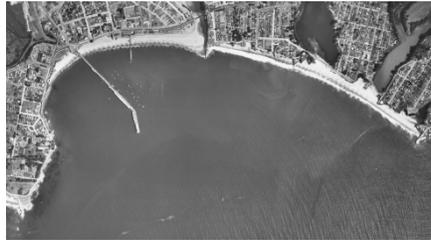
A 1956 aerial photograph of Main and Seabright Beaches showing the San Lorenzo River heading straight out to sea and a narrow Seabright Beach as there was no harbor and no jetties to trap sand and widen the beach.

Prior to harbor construction, Seabright or Castle Beach had always been quite narrow. In the old days, waves reached the base of the bluff each winter, and the sandstone bluffs were actively eroding. A walk along East Cliff Drive today above Seabright Beach between 1st and 4th Avenues still reveals isolated remnants of the old concrete roadway perched thirty feet above the beach like pedestals.

In 1963, as soon as the west jetty was completed, Seabright Beach began to widen. It continued to widen for the next twenty years or so, as littoral drift from upcoast was trapped against the jetty. Where waves previously crashed against the base of the bluff, a sandy beach 200 to 400 feet wide formed, offering year round protection except during periods of high tides and very large waves. It also provided an inviting wide new beach for residents and summer visitors.

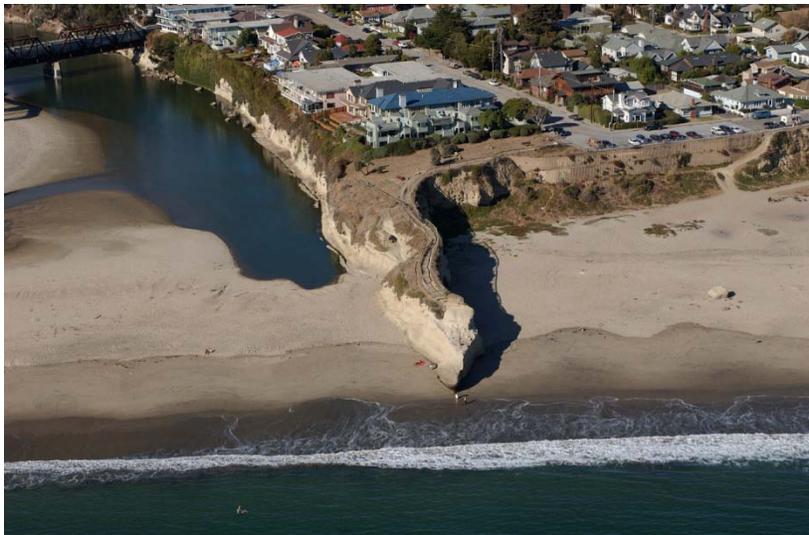
2005 photograph showing a very wide Seabright Beach and a wide sandbar causing the San Lorenzo River to flow upcoast along the back beach.

As Seabright Beach continued its expansion further seaward, it eventually extended out as far as the end of San Lorenzo Point, and beyond in recent years. The damming effect of the jetty gradually began to impact Main Beach as well. Sand backed up on the beach and widened it. Aerial photographs taken during the summer months over the past 25 years often show a wider sand bar forming at the mouth of the river.

At about this same time, the sand bar and beach at the river mouth were gradually getting wider as sand backed up by the harbor jetty continued to extend further to the west. The overall effect of this additional sand accumulation, when combined with the typical low flow of the San Lorenzo in years with low rainfall, has been a wider dam across the mouth of the river.

In response, the river in recent years has often taken a different course, flowing west along Main Beach where the sand is often at a lower elevation than the crest of the sand bar. This has led to a broad pond on the beach in front of the Boardwalk at times. The entire flow of the river this year went west, along the base of the retaining wall that protects and supports the Boardwalk.
