**Our Ocean Backyard — *Santa Cruz Sentinel* columns by Gary Griggs, Director, Institute of Marine Sciences, UC Santa Cruz.**

**#59 July 17, 2010**

**Seacliffs and seawalls**

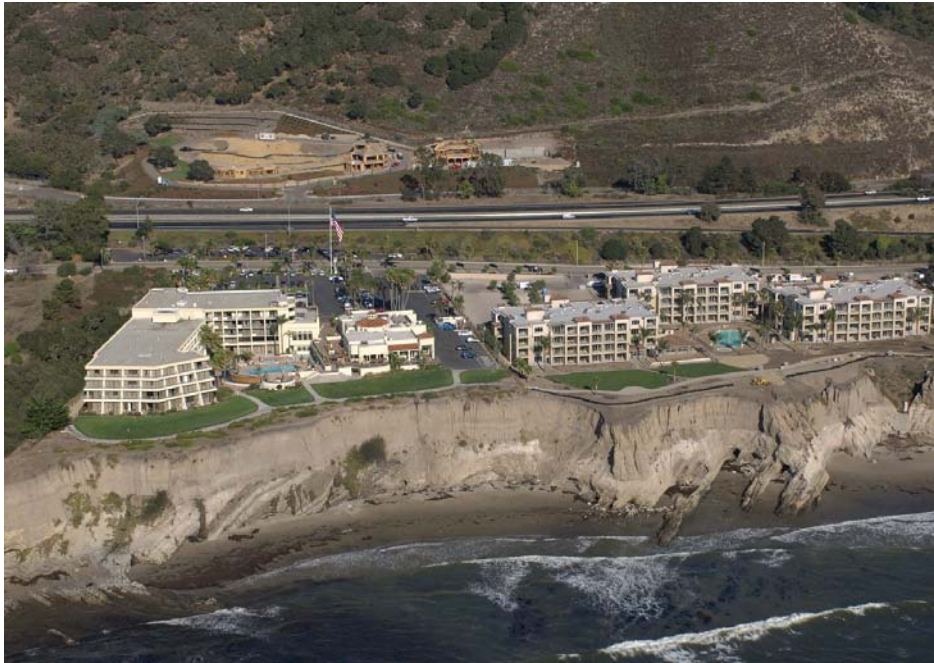
*The Cliffs Hotel in Pismo Beach was built too close to the cliff edge and led to a request for a seawall shortly after construction.*
